# Marine Sewage tank repaired with Belzona

ID: 8676

Industry: *Marine*  
Application: *VPF-Valves, Pipes and Fittings*  
Substrate: *Mild Steel*  
Products: *\* Belzona 1212 ,  
\* Belzona 1981 (Superwrap II Resin) ,  
\* Belzona 9381 (Superwrap II Reinforcement) ,  
\* Belzona 5811 (Immersion Grade) ,*

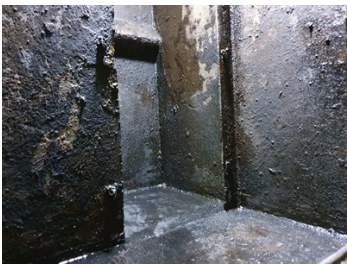
- \* 1 - Existing coating system breaking down ,
- \* 2 - Belzona Superwrap II system applied to the base of the tank ,
- \* 3 - 1st coat of Belzona 5811 applied ,
- \* 4 - 2nd coat of Belzona 5811 applied & left to cure ,

A marine sewage tank was identified as having thin wall areas on its base caused by corrosion. The existing protective coating system inside the tank had broken down. A repair & protection system was required to extend the life of the asset.

The application was carried out in a modified version of Belzona System Leaflet VPF-11 The tank internals were grit blasted to SA2.5 & 75 microns. All of the existing lining was removed. Areas of pitting and metal loss were faired with Belzona 1212. The full tank floor was then reinforced with the Belzona Superwrap II system. Two coats of Belzona 5811 were then applied over all areas of the
