Belzona protects tank from external corrosion

ID: 8684

Industry: *Food & Drink*
Application: *TCC-Tanks and Chemical Containment Areas*
Substrate: *Steel*
Products: ** Belzona 5811 (Immersion grade),*

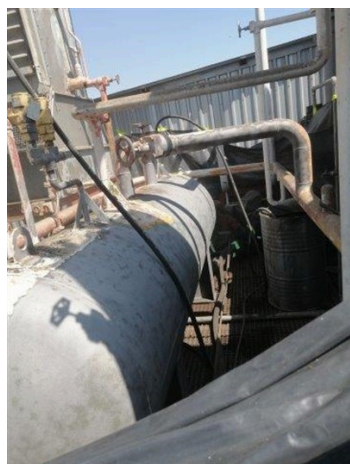
External corrosion and chemical attack of the existing coating

* 1. Tank prior to surface preparation 2. Tank during surface preparation 3. Tank post surface preparation 4. Completed Application ,

The surface was grit blasted and Belzona 5811 applied per IFU and system leaflet TCC-03
