Belzona protects tank from external corrosion

ID: 8684

Industry: *Food & Drink*
Application: *TCC-Tanks and Chemical Containment Areas*
Substrate: *Steel*
Products: ** Belzona 5811 (Immersion grade),*

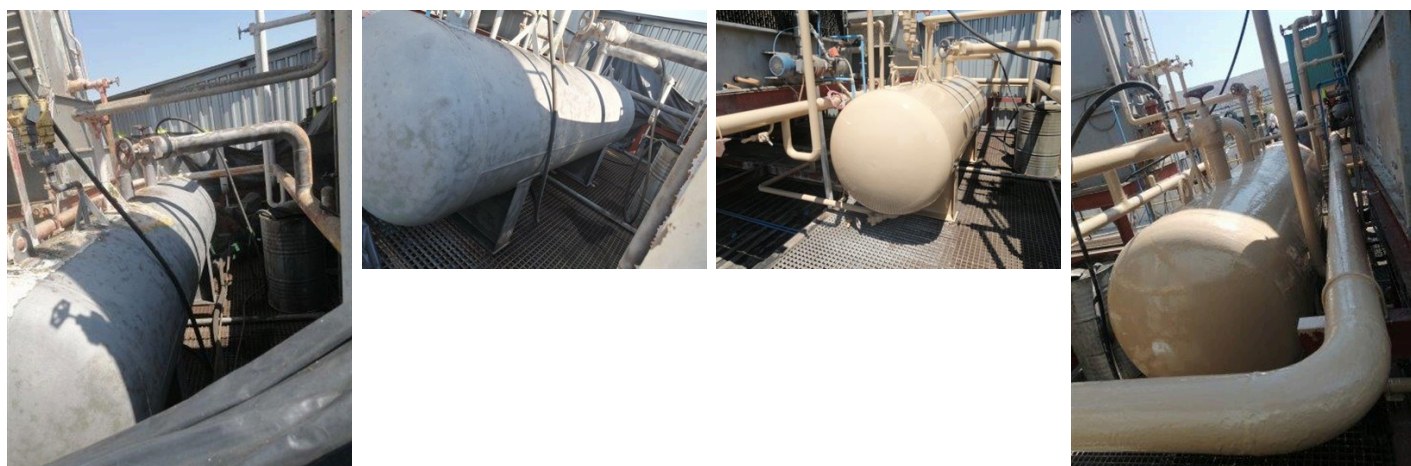
Photograph Descriptions

External corrosion and chemical attack of the existing coating

* 1. Tank prior to surface preparation 2. Tank during surface preparation 3. Tank post surface preparation 4. Completed Application ,

The surface was grit blasted and Belzona 5811 applied per IFU and system leaflet TCC-03
