Belzona stops a leak and strengthens a pipe.

ID: 8685

Industry: *Marine*
Application: *VPF-Valves, Pipes and Fittings*
Substrate: *Steel*
Products: ** Belzona 9611 ,*
** Belzona 1212 ,*
** Belzona 1111 ,*
** Belzona 9341 ,*

Customer Location: *NW Washington*
Application Date: *July 2021*

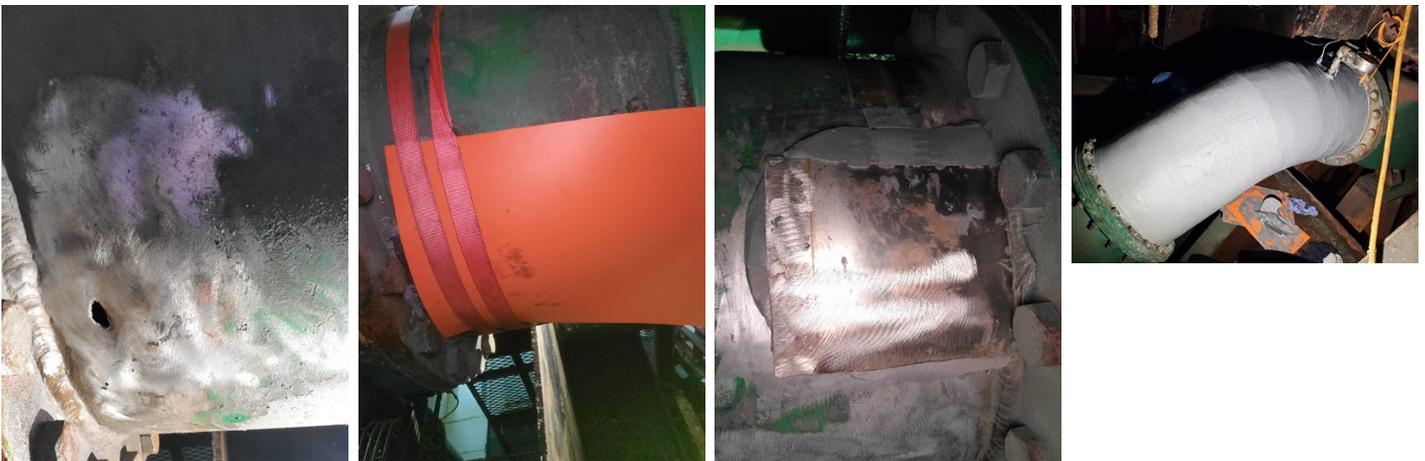
There was a fair-size hole and a large thin-wall area on the elbow of a 30" circulation pipe on a sea vessel. The hole was located where the pipe passed through a bulkhead at the very bottom of the vessel.

- * 1. Close pictures of the hole. ,
- * 2. The Belzona mixing board strapped in place. ,
- * 3. Belzona 1212 and doubler plate. ,
- * 4. Application complete. ,

The area around the hole was prepared with a grinder and Belzona 9611 was used for the initial plug. Belzona 1212 was then applied with a doubler plate over the Belzona 9611 since water was still present, and a Belzona mixing board was strapped into place over the Belzona 1212 and plate until it was hard. The remainder of the 30" elbow was prepared with a grinder and washed off with solvent. Belzona 1111 was then brushed into the surface, and loaded onto the Belzona 9341 reinforcement sheet and then

wrapped around the pipe from one end to the other. A final layer of Belzona 1111 was applied over the wrap to finish the application.

After a year and a half later, the repair is still in good condition. Customer has, since, done the same application on the other side of the same vessel as a preventive measure.
