Belzona restores and protects a Hydro Unit

ID: 8686

Customer Location: NW Washington
Application Date: April 2021

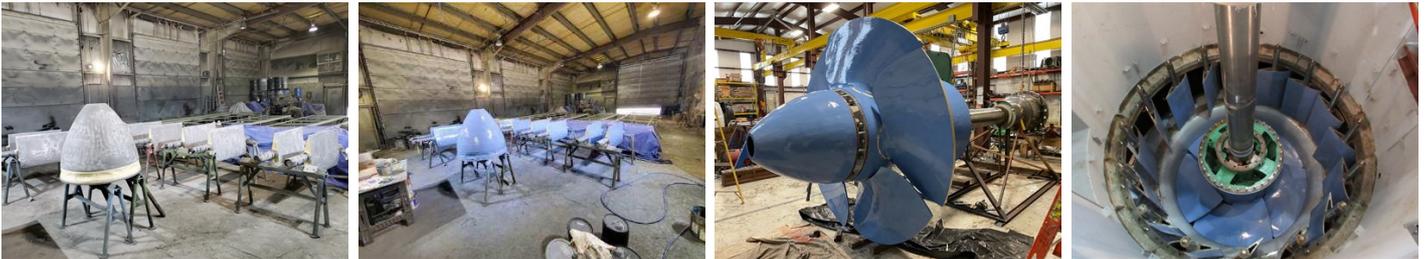
Photograph Descriptions

- * 1. Belzona 1111 applied. ,
- * 2. Belzona 1341 applied. ,
- * 3. Assembled, and final touch-ups complete. ,
- * 4. Unit reinstalled. ,

The parts were all grit blasted and washed with solvent. Belzona 1111 was used to smooth over the wear and cavitation in a full skim coat. Once cured, the Belzona 1111 was sanded down to the required profile, and frost blasted. Two full coats of Belzona 1341 were then applied. As per Belzona system leaflet VPF-01, VPF-02.
