# SIMPLE OVERHEAD REPAIRS WITH BELZONA® 4141

Application: RPA-Roof Problem Areas

Concrete support columns for electricity supply cables at local sub-station

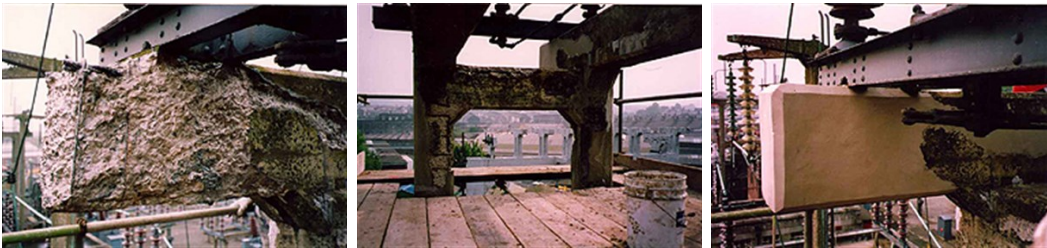
Severe spalling of the concrete accelerated by the acidic atmosphere generated by local industries

- \* Close up of the badly spalled concrete ,
- \* Work carried out from simple scaffold platform ,
- \* Close-up of a rebuilt beam prior to application of Belzona® 5151 ,

Application was carried out using similar techniques to those detailed in Belzona Know-How leaflet RPA-2. Repairs were finally overcoated with Belzona® 5151 as preventive maintenance on surrounding concrete surfaces.

Use of Belzona® 4141 allowed rebuilding to be carried out without the need to construct special shuttering and use of Belzona® 5151 will ensure similar problems on surrounding areas will not occur.
