SuperWrap II Repair on 4" Diesel Line in the Gulf of Mexico

ID: 8702

Application Date: *November 2021*

Substrate: *Carbon Steel - 4" Pipe*

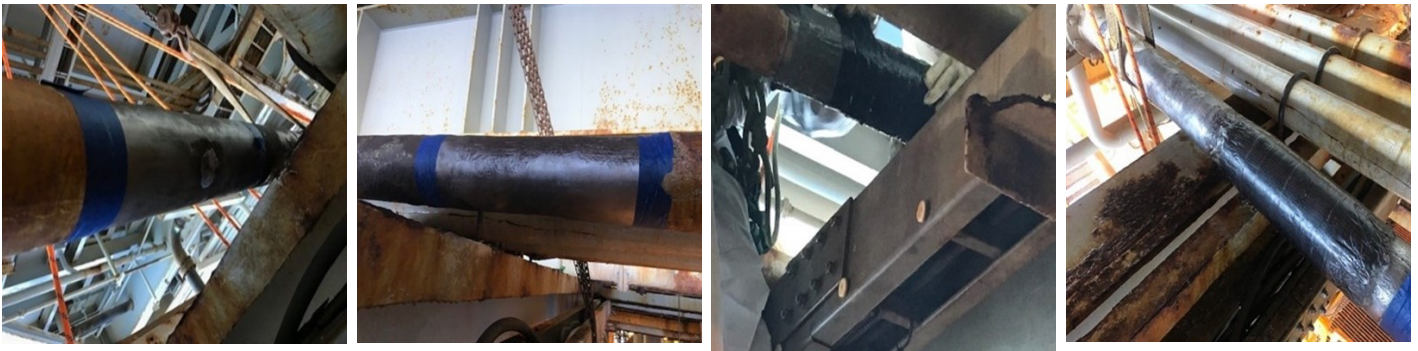
Photograph Descriptions

There was a through wall defect roughly 1/2" in size on a 4" diesel line. Belzona was used to fill the hole and wrap the location as an immediate preventative measure to give time for the construction team to be able to fabricate a spool piece and permanently replace.

1. Belzona 9611 applied to plug hole
2. Surface prep complete
3. Belzona 9381 being wrapped around the pipe.
4. Completed repair after cure.

1. Surface preparation using needle guns, SSPC-SP 11

2. Plug the hole with Belzona 9611
3. Fill pitting and smooth out defect area with Belzona 1161
4. Apply SuperWrap II per design using Belzona 1982, 9381, and 9382.
