Restoration of Turbine Stay Ring and Vanes with Belzona

Customer Location: Hydroelectric Power Plant, Turkey
Application Date: November 2021

Repair of the stay rings and draft tube of a 140Mw turbine operating within a hydroelectric power plant.

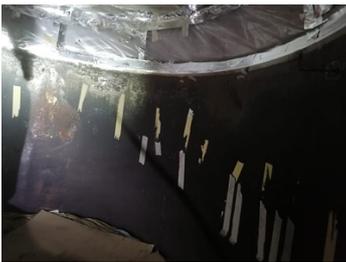
After 10 years of operation, the stay ring and vanes had lost thickness due to erosion. During a routine inspection, the surfaces had also been identified as being rough, resulting in a loss of efficiency and an increase in power consumption. The cause of roughness on the stay ring and vanes was because of foreign matter (sand, silt, mud etc.) within the process.

- * 1.) Damaged stay ring prior to application ,
- * 2.) The fixed wings before the application ,
- * 3.) The stay ring after the application ,
- * 4.) Final application - Belzona 1341 + Belzona 2141 ,

First, the turbine was grit blasted to SA2.5, achieving a surface profile of 75 microns before being cleaned with Belzona 9111. Once the surface was clean & dry, the pitted stay ring, vanes and draft tube were rebuilt with Belzona 1311, restoring the equipment back to its original dimensions. After the Belzona 1311 had cured, the surface was frost blasted (40 microns) before applying Belzona 1321 to the draft tube and Belzona 1341 to stay ring and vanes. Finally Belzona 2941 & Belzona 2141 were applied to the tips of the stay vanes for their anti-cavitation properties.
