# Belzona Repairs and Protects Francis Turbine

**Customer Location:** Hydroelectric Power Plant, Turkey  
**Application Date:** December 2021

Restoration of a 91Mw francis turbine within an Hydroelectric power plant.

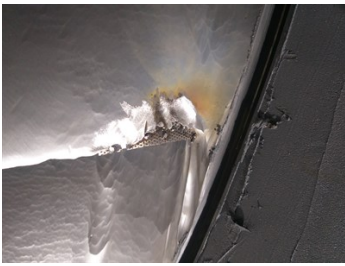
Over time, the turbine had suffered from serious erosion, cavitation and several parts of the vanes had deteriorated due to foreign matter entrained within the process. During an inspection, severe pitting was identified in the draft tube area.

- \* 1.) Rebuilt damaged vanes with perforated sheet ,
- \* 2.) Cavitated vane tips repaired with Belzona 1311 ,
- \* 3.) 1st coat of Belzona 1341 ,
- \* 4.) Final application ,

the surface was clean & dry, any severely pitted areas or damaged vanes were rebuilt with Belzona 1311 along with perforated metal sheets, restoring the turbine back to it's original dimensions. After the 1311 had cured, the surface was frost blasted (40 microns) before applying 2 coats of Belzona 1341. Finally Belzona 2941 conditioner and Belzona 2941 were applied to the the tips of the turbines vanes as these areas were most susceptible to cavitation.
