Solving the Sealing Problem on the Roof of the Fuel Storage Tank with Belzona

ID: 8708

Customer Location: Tank Farm, TURKEY

Application Date: April 2021

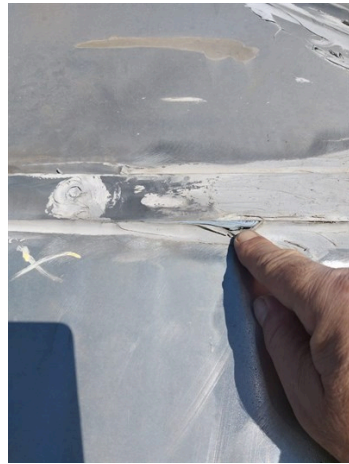
Rainwater was leaking from the external surface of the tank roof through the seams. The client tried to use a different system to fix the problem, although that solution was unsuccessful.

- * 1.) General view of fuel storage tanks ,
- * 2.) Failed current system ,
- * 3.) Taping and Belzona 3921 application ,
- * 4.) A view from the Belzona 3111 application ,
