# BELZONA REPAIR TO POWER PLANT COAL BELT

ID: 874

Application: SHM-Solids Handling Machinery

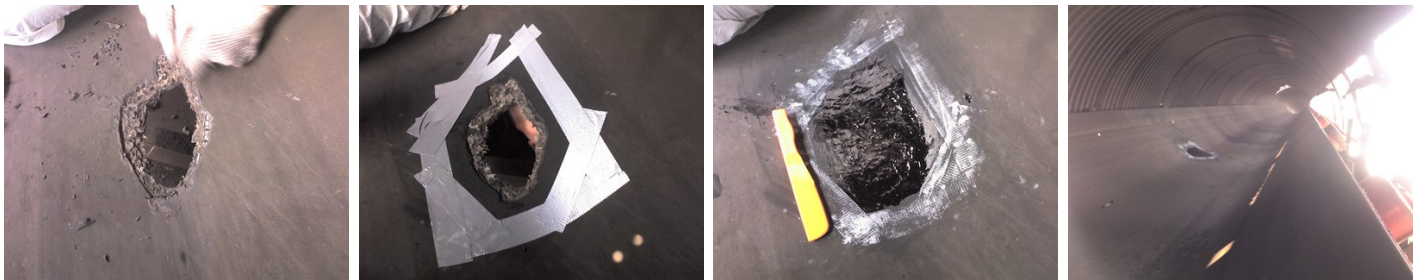
Belt developed a large burn hole. This rendered the belt unusable until fixed.

\* Hole in the belt being prepared , \* Preparation completed , \* Completed application , \* Completed application ,

Belt was repaired according to Belzona System Laflet SHM-1
