BELZONA REPAIR TO POWER PLANT COAL BELT

ID: 874

Application: SHM-Solids Handling Machinery

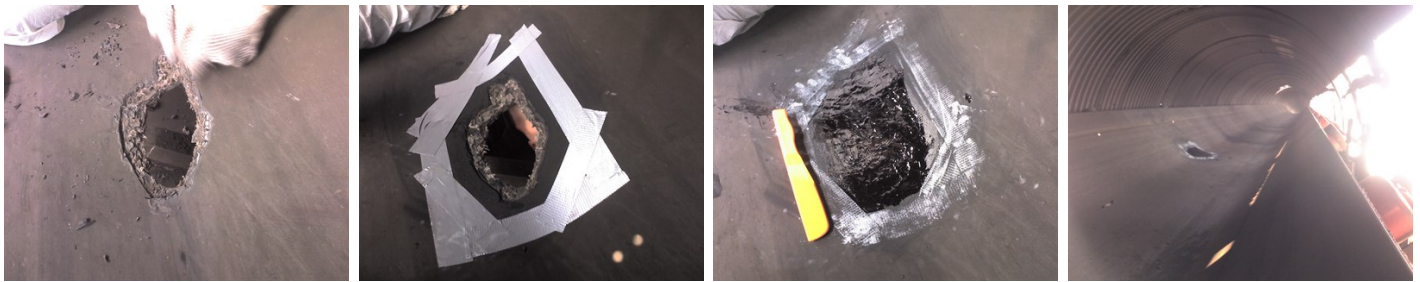
Photograph Descriptions

Belt developed a large burn hole. This rendered the belt unusable until fixed.

* Hole in the belt being prepared , * Preparation completed , * Completed application , * Completed application ,

Belt was repaired according to Belzona System Laflet SHM-1
