COAL CONVEYER REPAIRED WITH BELZONA ELASTOMER

Application: SHM-Solids Handling Machinery

Customer Location: Power Plant, Missouri

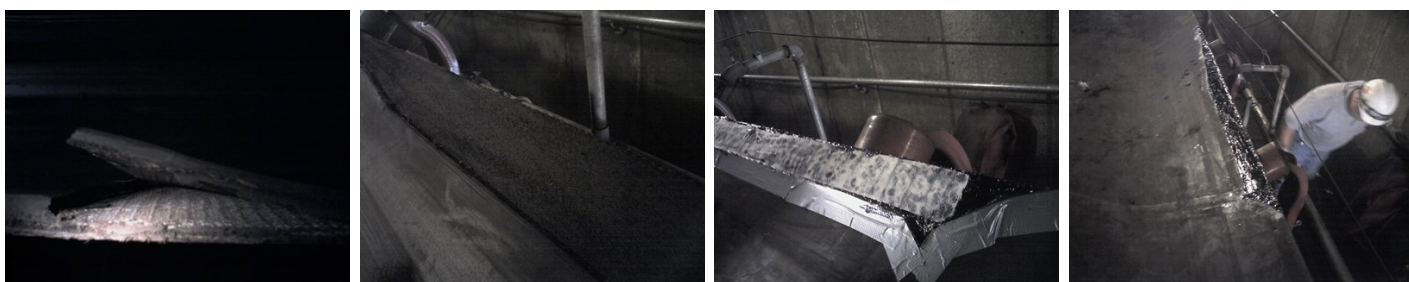
Photograph Descriptions

The belt had delaminated and lost the top two plies in areas. Plant officials worried that the belt integrity was in jeopardy due to the extensive damage.

- * Belt damage ,
- * Another view of the damaged area ,
- * Application underway with reinforcement tape being embedded in elastomer ,
- * Completed repair ,

Belt was repaired in accordance with Belzona Know-How System Leaflet SHM-1.
