COAL CONVEYER REPAIRED WITH BELZONA ELASTOMER

ID: 876

Industry: Power
Application: SHM-Solids Handling Machinery

Customer Location: Power Plant, Missouri
Application Date: 2007

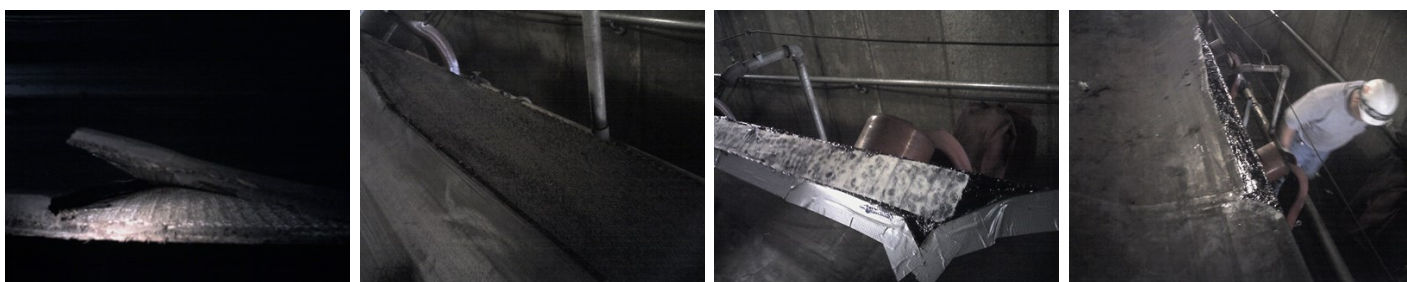
Photograph Descriptions

The belt had delaminated and lost the top two plies in areas. Plant officials worried that the belt integrity was in jeopardy due to the extensive damage.

- * Belt damage ,
- * Another view of the damaged area ,
- * Application underway with reinforcement tape being embedded in elastomer ,
- * Completed repair ,

Belt was repaired in accordance with Belzona Know-How System Leaflet SHM-1.
