# Belzona Protects a Leading Edge of a Wind Turbine Blade

ID: 8769

Customer Location: Wind Farm, TX  
Application Date: 2021

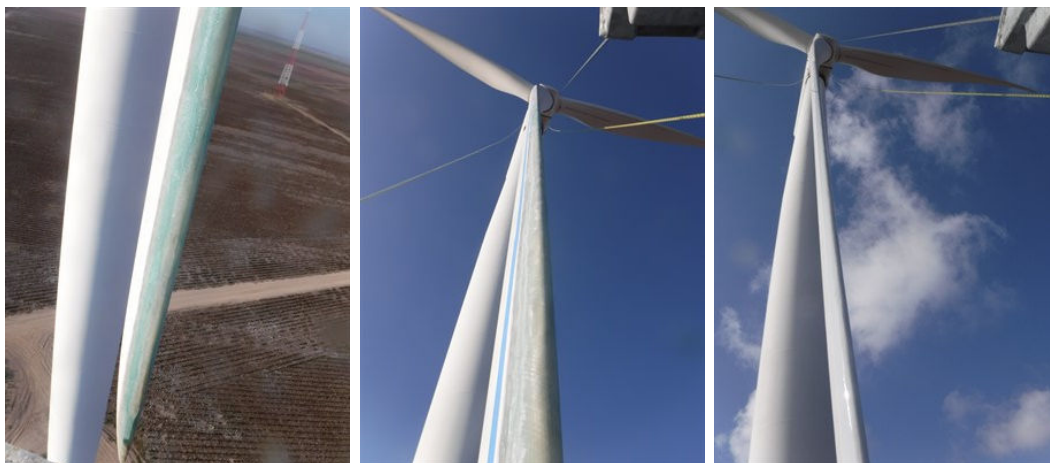
*Leading Edge Erosion (LEE). The effects of raindrops, sand and hail chewed-up the leading edge on the rotating blades. If not repaired, LEE can leave the blades unbalanced, affecting the shaft and gearbox resulting in energy loss.*

- \* 1. Gel coat removed. ,
- \* 2. The blade fully prepped. ,
- \* 3. Finished application with Belzona 5721 in white. ,

The application was carried out in accordance with the Belzona System Leaflet FBC-16 and Belzona 5721 "Instructions For Use". First the surface was rebuilt using Belzona 1221. 2911 conditioner was applied to the coating area to have optimum adhesion. Then the surface was overcoated with one coat of Belzona 5721 - LEP coating.
