# LARGE HOLE IN TANK REPAIRED WITH BELZONA

Industry: Power  
Application: TCC-Tanks and Chemical Containment Areas  
Substrate: Carbon Steel  
Products: Belzona® 1121 (Super XL-Metal)

Customer Location: Coal fired Power Plant, Missouri  
Application Date: 2007

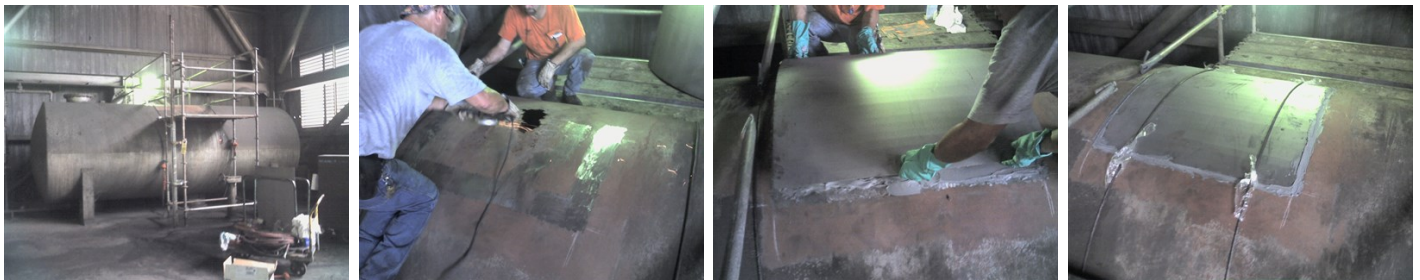
The tank developed a large hole in the top due to years of corrosion

\* General view of the tank , \* Surface preparation underway , \* Doubler plate being positioned and bonded in place , \* Completed repair ,

Tank was repaired in accordance with Belzona Know-How System Leaflet TCC-1. Doubler plate was bonded over the holed area.
