Belzona Repairs and Protects Wind Turbine Columns

ID: 8771

Customer Location: Wind Farm, TX
Application Date: 2022

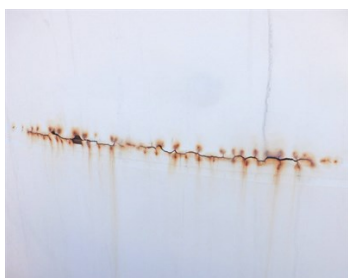
Damage on the surface of the columns caused by salt deposits from rain and fog settlements. Elements create corrosive areas on equipment and metallic columns are no exception. The Customer felt if the issue was not addressed in due time, through-wall defects could lead to a loss of structural integrity, which could pose a bigger issue long-term.

- * Showing damage. ,
- * The area is prepped using an MBX Bristle Blaster, and masked off for the application. ,
- * Belzona 1331 is applied and the application is complete. ,

Customer needed a solution requiring minimal effort from labor. Access was only by wire rope and staging basket. Abrasive media blasting was not allowed. An MBX Bristle Blaster was used to acquire a surface profile of 3 mils. MEK was used to clean and degrease the application area. Then one high-build coat of Belzona 1331 was applied by brush in one staging. The application was carried out in accordance with a modified version of Belzona System Leaflet CEP-4 and Belzona 1331 Instructions for Use.
