# Belzona Repairs and Protects Wind Turbine Columns

ID: 8771

Customer Location: Wind Farm, TX  
Application Date: 2022

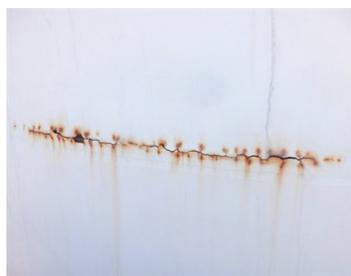
Damage on the surface of the columns caused by salt deposits from rain and fog settlements. Elements create corrosive areas on equipment and metallic columns are no exception. The Customer felt if the issue was not addressed in due time, through-wall defects could lead to a loss of structural integrity, which could pose a bigger issue long-term.

- \* Showing damage. ,
- \* The area is prepped using an MBX Bristle Blaster, and masked off for the application. ,
- \* Belzona 1331 is applied and the application is complete. ,

Customer needed a solution requiring minimal effort from labor. Access was only by wire rope and staging basket. Abrasive media blasting was not allowed. An MBX Bristle Blaster was used to acquire a surface profile of 3 mils. MEK was used to clean and degrease the application area. Then one high-build coat of Belzona 1331 was applied by brush in one staging. The application was carried out in accordance with a modified version of Belzona System Leaflet CEP-4 and Belzona 1331 Instructions for Use.
