# Belzona 4301 Rebuilds An Acid Intake Nozzle

Industry: Chemical & Petrochemical  
Application: VPF-Valves, Pipes and Fittings  
Substrate: Steel  
Products: \* Belzona 4301 (Magma CR1 Hi-Build) ,

Customer Location: South Africa  
Application Date: February 2022

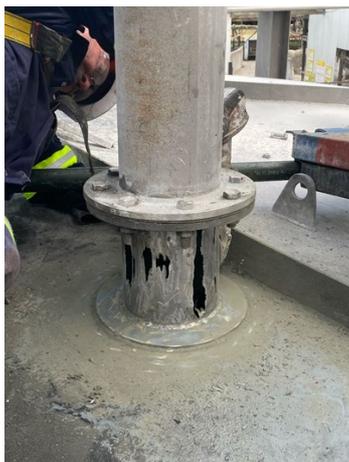
The acid used in the process had severely damaged steel, affecting its structural integrity

- \* 1 - Initial condition ,
- \* 2- Surface Preparation ,
- \* 3 - Belzona 4301 Application ,
- \* 4 - Belzona 4301 Application ,

An acid intake nozzle was severely compromised, requiring an urgent repair.
