Belzona 4301 Rebuilds An Acid Intake Nozzle

ID: 8772

Industry: Chemical & Petrochemical
Application: VPF-Valves, Pipes and Fittings
Substrate: Steel
Products: * Belzona 4301 (Magma CR1 Hi-Build) ,

Customer Location: South Africa
Application Date: February 2022

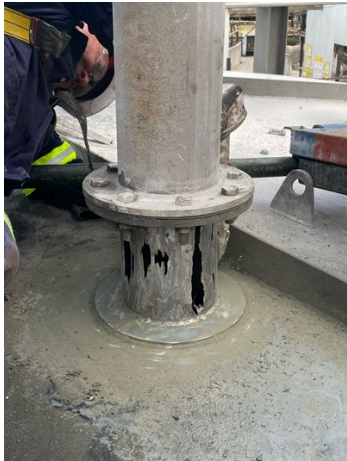
The acid used in the process had severely damaged steel, affecting its structural integrity

- * 1 - Initial condition ,
- * 2- Surface Preparation ,
- * 3 - Belzona 4301 Application ,
- * 4 - Belzona 4301 Application ,

An acid intake nozzle was severely compromised, requiring an urgent repair.
