Belzona Protects Against Corrosion In Fan Shroud

ID: 8775

Industry: *Pulp & Paper*
Application: *FBC-Fans, Blowers and Compressors*

Substrate: *Aluminum*
Products: *Belzona 5811 (Immersion Grade),*

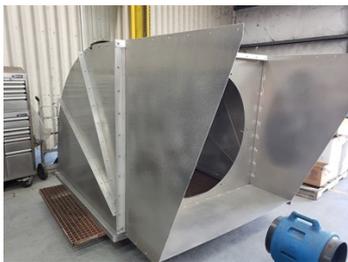
A brand new paper milling fan shroud picks up a lot of caustic mist, eventually corroding the inside of the shroud. A coating was then required to protect the shroud from the corrosion that would have eventually formed over time.

Fan shroud.

Preparation was done by a combination of abrasive blasting and MBX by hand to achieve a SP10 near white metal finish for a good mechanical adhesion. Belzona 5811 was then mixed and applied as two coats on the shroud.

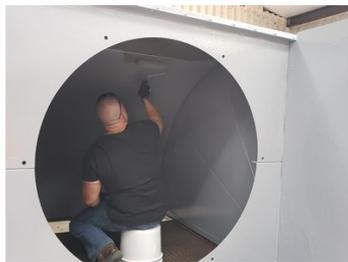
Fan shroud being coated.

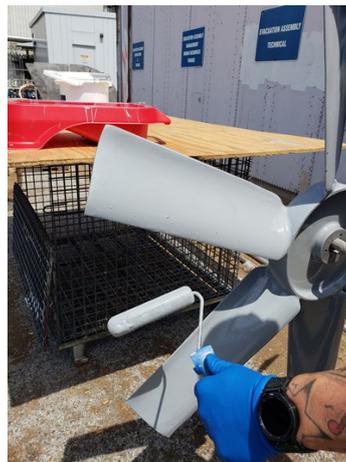
Fan being coated

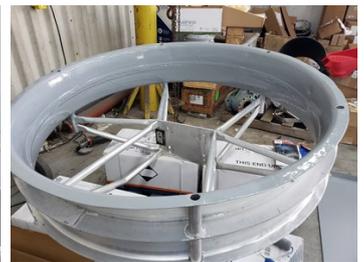
Coated pieces.
