Wind Turbine Bedframe Repaired with Belzona

ID: 8776

Industry: Power
Application: GSS-Gaskets, Seals and Shims
Substrate: Carbon steel
Products: Belzona 1111 (SuperMetal),

Customer Location: Scotland
Application Date: April 2022

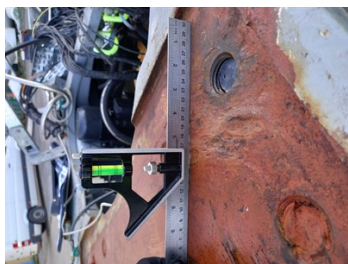
Metal loss shown on the casing

A wind turbine nacelle bedframe had become damaged through corrosion. The corrosion had formed pitted areas where the main shaft pedesal is landed. A flat surface was required to bolt onto with no gaps where water could ingress & cause future corrosion.

Power tool preparation on the damaged surfaces

The application was carried out in accordance with Belzona System Leaflet GSS-06. The area was first prepared with an angle grinder & MBX Bristle Blaster. The Belzona 1111 Supermetal was then applied proud of the surrounding metal. Once it reached its initial cure stage it was then sanded down flat with the undamaged sections of the casing.

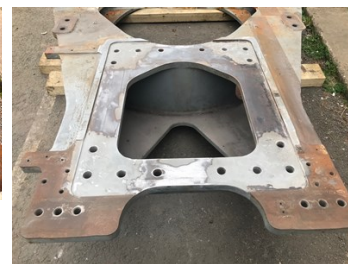
The Belzona 1111 machined flat with the surrounding metal

The Belzona repair was carried out without the risk of distortion of the casing. Once cured the product has a very high compressive strength, it also does not corrode in normal conditions so it will prevent future corrosion if water does reach the area.
