# Wind Turbine Bedframe Repaired with Belzona

ID: 8776

Customer Location: Scotland  
Application Date: April 2022

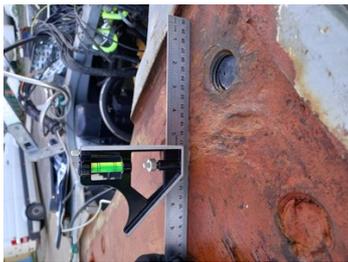
Metal loss shown on the casing

A wind turbine nacelle bedframe had become damaged through corrosion. The corrosion had formed pitted areas where the main shaft pedesal is landed. A flat surface was required to bolt onto with no gaps where water could ingress & cause future corrosion.

The application was carried out in accordance with Belzona System Leaflet GSS-06. The area was first prepared with an angle grinder & MBX Bristle Blaster. The Belzona 1111 Supermetal was then applied proud of the surrounding metal. Once it reached its initial cure stage it was then sanded down flat with the undamaged sections of the casing.

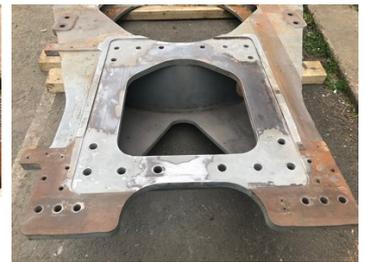
The Belzona 1111 machined flat with the surrounding metal

The Belzona repair was carried out without the risk of distortion of the casing. Once cured the product has a very high compressive strength, it also does not corrode in normal conditions so it will prevent future corrosion if water does reach the area.
