Wind Turbine Bedframe Repaired with Belzona

ID: 8776

Customer Location: Scotland
Application Date: April 2022

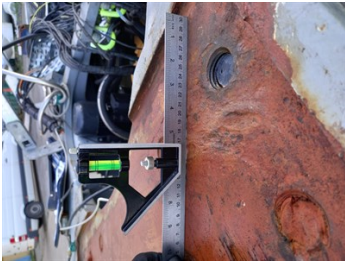
Metal loss shown on the casing

A wind turbine nacelle bedframe had become damaged through corrosion. The corrosion had formed pitted areas where the main shaft pedesal is landed. A flat surface was required to bolt onto with no gaps where water could ingress & cause future corrosion.

The application was carried out in accordance with Belzona System Leaflet GSS-06. The area was first prepared with an angle grinder & MBX Bristle Blaster. The Belzona 1111 Supermetal was then applied proud of the surrounding metal. Once it reached its initial cure stage it was then sanded down flat with the undamaged sections of the casing.

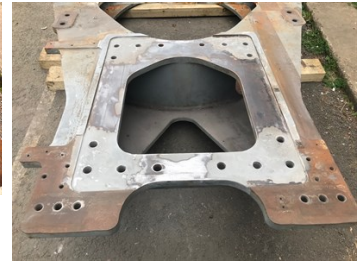
The Belzona 1111 machined flat with the surrounding metal

The Belzona repair was carried out without the risk of distortion of the casing. Once cured the product has a very high compressive strength, it also does not corrode in normal conditions so it will prevent future corrosion if water does reach the area.
