Belzona Protects an Alstom Seawater Pump Valve

Application: PDP-Positive Displacement Pumps

Customer Location: Jorf Lasfar, Morocco

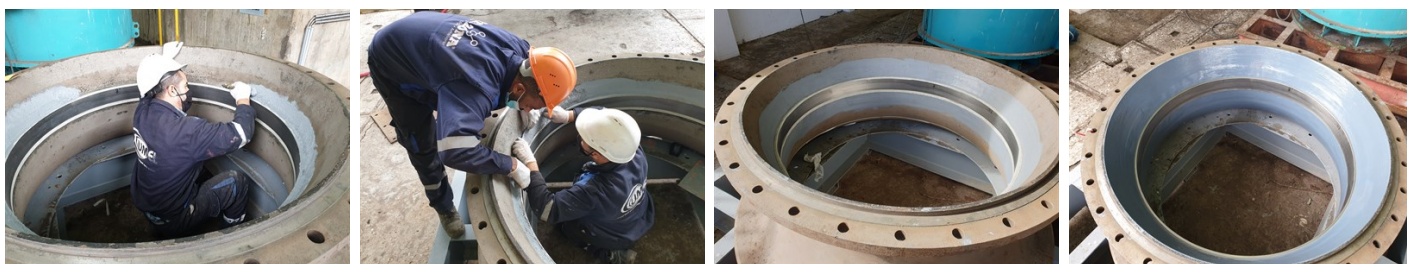
Photograph Descriptions

The valve on an Alstom sea pump suffered from erosion due to sea water and needed to be repaired and protected against future wear along with other parts of the pump.

* 1). Belzona 1111 pushed into the surface profile with a bristle brush. 2). Belzona 1111 & Belzona 9341 reinforcement sheet is added to provide strength. 3). Completed Belzona 1311 rebuild repair. 4). Completed application overcoated with Belzona 1321. ,

The valve was rebuilt on the inside using Belzona 1111 and then reinforced using Belzona 9341 before being overcoated using Belzona 1321. The application was carried out in accordance with Belzona System Leaflet PDP-05.
