Seawater Pump gets the full Belzona Service

ID: 8789

Industry: Chemical & Petrochemical
Application: CEP-Centrifugal Pumps
Substrate: Cast Iron
Products: * Belzona 1111 (Super Metal) ,
* Belzona 1321 (Ceramic S-Metal) ,

Customer Location: Jorf Lasfar, Morocco
Application Date: March 2019

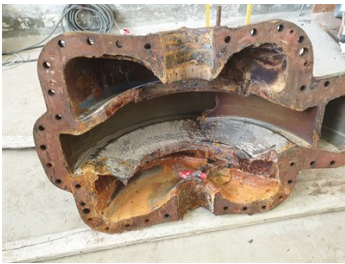
The Kirloskar seawater pump was suffering from general corrosion and bi-metallic corrosion (galvanic corrosion) on the wear rings.

- * 1). Original condition of the seawater pump casing. ,
- * 2). Wear rings and cutwaters being rebuilt using Belzona 1111. ,
- * 3). Pump impeller rebuilt and protected. ,
- * 4). Completed seawater pump application. ,

The seawater pump was grit-blasted, the cutwaters and wear rings were then rebuilt to their original OEM profile using Belzona 1111 before being overcoated with Belzona 1321. The pump impeller was also rebuilt and protected against corrosion. The application was carried out in accordance with Belzona System Leaflet CEP-01 & CEP-02.
