Belzona Repairs Pump Mouth

ID: 8797

Industry: Water / Wastewater
Application: CEP-Centrifugal Pumps
Substrate: Steel
Products: * Belzona 1311 (Ceramic R Metal) ,
* Belzona 1321 (Ceramic S Metal) ,
* Belzona 5821 ,

Customer Location: Northern Germany
Application Date: 2022

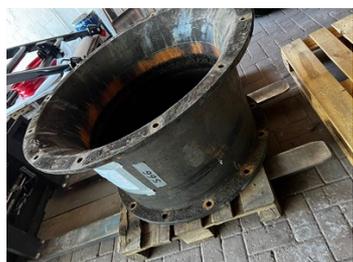
Heavy corrosion in the area where the propeller runs.

- * Image 1: Pump Mouth to Repair ,
- * Image 2: Close up heavy corrosion ,
- * Image 3: Belzona Products Applied ,
- * Image 4: Complete Application ,

After blasting in accordance with Belzona standards the corroded areas were filled with Belzona 1311 and then coated the complete inside with two layers of Belzona 1321. The upper part we overcoated and then the external coating was coated with Belzona 5821. Please refer to Belzona systems leaflets CEP-03 & CEP-05 for further details of products that can be used for this type of application.

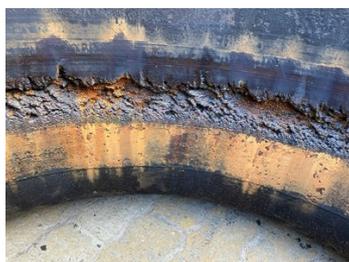
Waste Water Pump has suffered heavy corrosion during operation and is need of repair a replacement would cost the client 11.000 EUROS.
