Pipe Repair at a Pump Station

ID: 8800

Customer Location: Northern Germany

Application: VPF-Valves, Pipes and Fittings

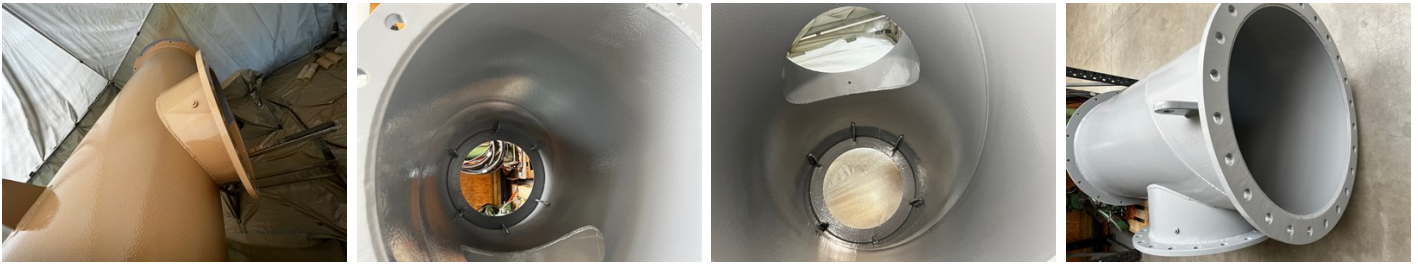
Photograph Descriptions

Heavy corrosion of the internal of the pipes needed repairing to ensure protection of dyke.

- * Image 1: First Layer of Belzona 5811 ,
- * Image 2: Second Layer of Belzona 5811 ,
- * Image 3: Internal Application Complete ,
- * Image 4: External Application Complete ,

A pipe at a pump station for the dyke protection had heavily corroded.

The heavy corroded areas were filled and smoothed with Belzona 1111. Belzona 5811 was used to coat the internal and external of the pipe for further corrosion protection.
