# BELZONA SAVES VITAL CHILLER

ID: 883

Industry: *General Industry*  
Application: *HEX-Heat Exchangers*  
Substrate: *Steel*  
Products: *Belzona® 1311 (Ceramic R-Metal)<br>Belzona® 1321 (Ceramic S-Metal)*

Customer Location: *Soybean Processor, Kansas*  
Application Date: *June 2007*

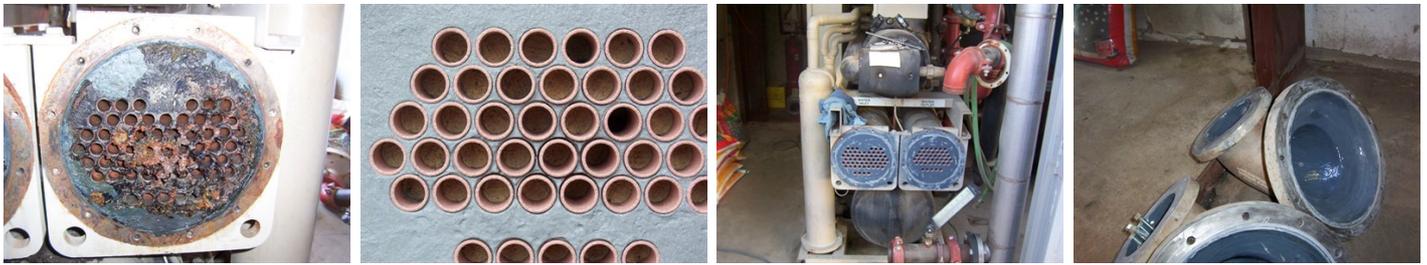
*Bi-metallic corrosion was deteriorating the tube sheet surfaces. If the problem was left unresolved, the chiller would eventually suffer severe damage through internal leakage.*

\* Original condition of tube sheet with scale build-up , \* Bi-metallic corrosion damage revealed by blast cleaning. Note the voids between the tubes and tubesheet. , \* Tube sheet. The surface was sanded to provide a perfect sealing surface. , \* Protected end covers ,

Application was carried out in accordance with Belzona System Leaflet HEX-1, 2 & 3. Belzona® 1311 was used to replace the missing metal. Two coats of Belzona® 1321 provides a corrosion barrier to the surfaces. A fine grit grind stone was used to smooth the surface. This allows the use of the OEM Trane o-ring seals.
