BELZONA REPAIRS AND PROTECTS MACHINE TOOL COOLANT TANK

Industry: General Industry
Application: TCC-Tanks and Chemical Containment Areas
Substrate: Mild Steel
Products: * Belzona® 1111 (Super Metal) ,
* Belzona® 5811 (Immersion Grade) ,

Customer Location: Aerospace Component Manufacturer, KS
Application Date: February 2007

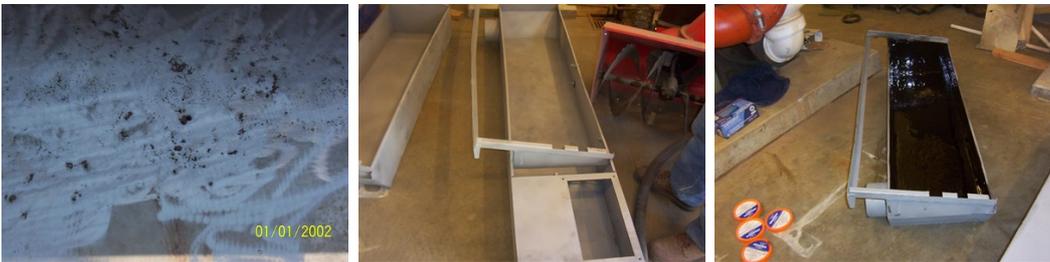
Photograph Descriptions

The cutting fluid is water based. The tanks rust because the cutting fluid and the cuttings sit on the bottom of the tank. The tanks leak and cause a big mess and safety hazard.

- * Typical rust holes ,
- * Blast cleaned tank ,
- * Totally sealed tank ,

Application was carried out in accordance with Belzona Know-How System Leaflet TCC-5.
