# Abrasion protection for sludge screw conveyor

ID: 8844

Industry: Water / Wastewater  
Application: SHM-Solids Handling Machinery

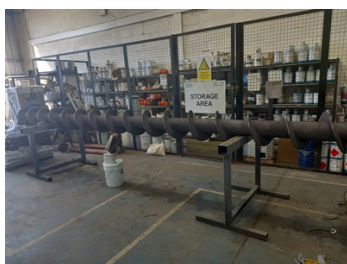
- \* 1 - Screw conveyor before ,
- \* 2 - Screw during application ,
- \* 3 - Belzona 1812 close up ,
- \* 4 - Belzona 1812 close up ,

A screw conveyor transporting waste sludge was suffering from abrasion & corrosion in service. A new screw conveyor was fabricated - heavy abrasion & corrosion resistance were required to extend its service life.

The screw conveyor was first grit blasted to SA 2.5 cleanliness & 75 microns profile. The Belzona 1812 (Ceramic Carbide FP) was then built up on the drive flights & the shaft body.
