# Abrasion protection for sludge screw conveyor

ID: 8844

Industry: Water / Wastewater  
Application: SHM-Solids Handling Machinery

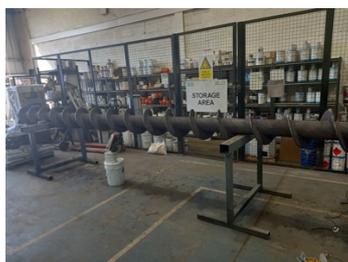
The bare steel had a short life expectancy in service. The sludge being transported by this screw was not only highly abrasive but also corrosive - these corrosive conditions would shorten the life of many abrasion resistant metal overlays.

- \* 1 - Screw conveyor before ,
- \* 2 - Screw during application ,
- \* 3 - Belzona 1812 close up ,
- \* 4 - Belzona 1812 close up ,

The screw conveyor was first grit blasted to SA 2.5 cleanliness & 75 microns profile. The Belzona 1812 (Ceramic Carbide FP) was then built up on the drive flights & the shaft body.
