Belzona Repairs a Live Water Leak on a Refrigerant Suction Pump

ID: 8846

Industry: Sugar

Pipe on a Closed Circuit Refrigeration System within a Sugar Refinery.

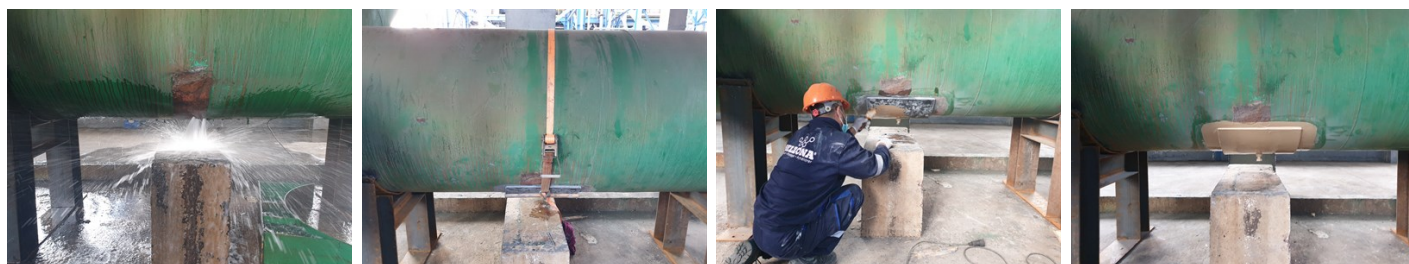
The pipeline connected to a suction pump on a closed circuit refrigeration system had suffered from bi-metallic corrosion (A.K.A galvanic corrosion) due to the pipe support, resulting in a complete loss of wall thickness at several locations, leading to live leaks needing to be repaired.

- * 1). Leaking pipe once the support was removed. ,
- * 2). Plate bond using Belzona 1212 and held in place using a strap during the polymerisation stage. ,
- * 3). Belzona 5811 applied over the plate to prevent any future corrosion in the area. ,
- * 4). Completed application, overcoated with Belzona 5811. ,

Supports were erected at either side of the original pipe support. The live leak was then plugged at the various locations using Belzona 9611 in order to divert the leak to one single area. A 10mm plate with a threaded outlet was then cold bonded using Belzona 1212 due to it's very short polymerisation window and held in place using a strap. Once fully cured, a threaded screw was threaded into the plate to stop the leak, followed by 2 coats of Belzona 5811 applied over the plate to prevent any corrosion occurring again in the area. The application was carried out in accordance with modified version of Belzona System Leaflet VPF-11.
