BELZONA PROTECTS BRINE PUMP BOWLS

Customer Location: Hydrocarbon Fractionation Facility /
Hutchinson, KS

Application: CEP-Centrifugal Pumps

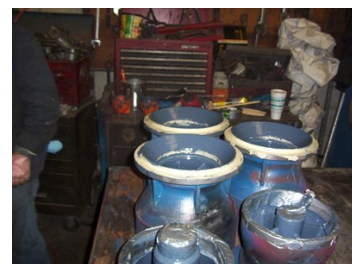
* Grit blasted bowl with surface profile sample , * Mixing Belzona® 1321 , * Application under supervision in progress , * Pump bowls with Belzona® 1321 applied ,

Application was completed in accordance with Belzona Know-How System leaflet CEP-3.
The pump bowls were heated to a pre-application temperature of 90°F.
