BELZONA PROTECTS BRINE PUMP BOWLS

Customer Location: Hydrocarbon Fractionation Facility /
Hutchinson, KS

Application: CEP-Centrifugal Pumps

Products: Belzona® 1321 (Ceramic S-Metal)

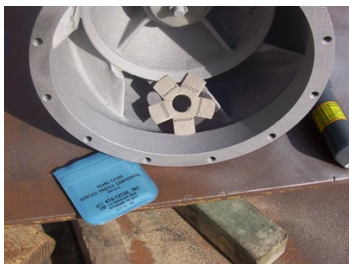
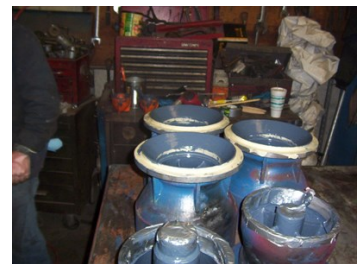
Photograph Descriptions

* Grit blasted bowl with surface profile sample , * Mixing Belzona® 1321 , * Application under supervision in progress , * Pump bowls with Belzona® 1321 applied ,

Application was completed in accordance with Belzona Know-How System leaflet CEP-3.
The pump bowls were heated to a pre-application temperature of 90°F.
