Belzona Ceramic Cladding Protects Bailing Machine

Industry: General Industry
Application: TCC-Tanks and Chemical Containment Areas
Substrate: Steel
Products: * Belzona 6111 (Liquid Anode) ,
* Belzona 5111 (Ceramic Cladding) ,

Customer Location: Speciality Fibre Manufacturer, UK
Application Date: July 2022

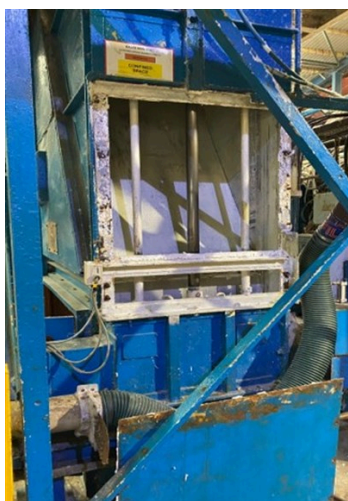
- * 1. Alumina fibre – Bailing machine ,
- * 2. Paint system deteriorating causing contamination and discolouring of the fibre ,
- * 3. Belzona system applied to three bailing machine sliding surfaces ,
- * 4. Completed repair ,

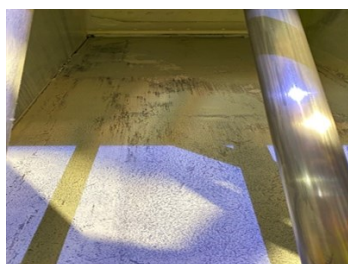
The steel was going rusty and the rust contaminating / discolouring the white coloured fibre prior to despatch to the customers.

The alumina fibre which is manufactured by the client is very aggressive and was wearing down the unprotected steel on a bailing machine.
