Belzona 1593 Proven to Provide Long Term Protection in Molten Sulphur

ID: 8856

Customer Location: Oil Refinery, UK
 Application Date: January 2016

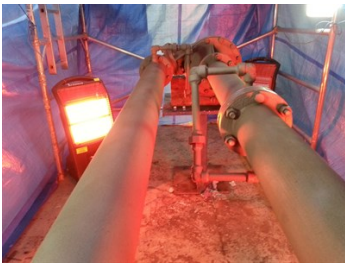
- * 1. Pipes grit blasted ready for application of Belzona coating ,
- * 2. Pipes coated with Belzona 1593 ,
- * 3. Pipes coated with Belzona 1593 ,
- * 4. Pipes revisited 5 years later showing minimal damage to the coating ,

The surface to be coated was grit blasted to a surface cleanliness of Sa2½. Belzona 1593 was then applied in two coats to provide outstanding corrosion protection. The application was carried out in accordance with Belzona Know-How System Leaflets VPF-2.

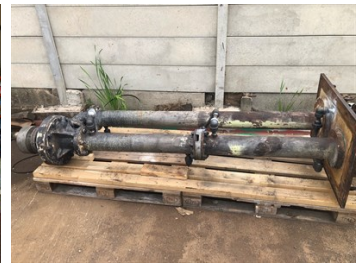
1593, the client was keen to utilise this improved solution however there was minimal testing available in this type of situation. This pump was originally coated in 2017, when the pumps were revisited in 2022, there was little damage to the coating. The client chose to fully recoat the pipes even though a small repair would have been sufficient.
