Belzona 1593 Proven to Provide Long Term Protection in Molten Sulphur

ID: 8856

Industry: Oil & Gas
 Application: VPF-Valves, Pipes and Fittings
 Substrate: Carbon Steel
 Products: * Belzona 1593 ,

Customer Location: Oil Refinery, UK
 Application Date: January 2016

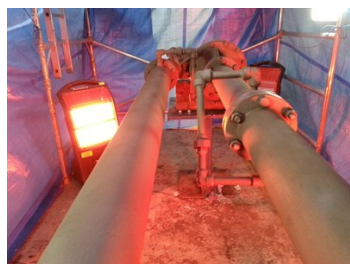
- * 1. Pipes grit blasted ready for application of Belzona coating ,
- * 2. Pipes coated with Belzona 1593 ,
- * 3. Pipes coated with Belzona 1593 ,
- * 4. Pipes revisited 5 years later showing minimal damage to the coating ,

The surface to be coated was grit blasted to a surface cleanliness of Sa2½. Belzona 1593 was then applied in two coats to provide outstanding corrosion protection. The application was carried out in accordance with Belzona Know-How System Leaflets VPF-2.

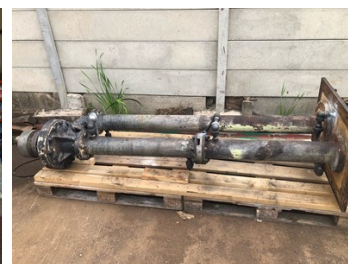
1593, the client was keen to utilise this improved solution however there was minimal testing available in this type of situation. This pump was originally coated in 2017, when the pumps were revisited in 2022, there was little damage to the coating. The client chose to fully recoat the pipes even though a small repair would have been sufficient.
