# Belzona prevents prolonged shutdown due to sulfuric acid flange leak

Industry: General Industry  
Application: VPF-Valves, Pipes and Fittings  
Substrate: Steel  
Products: \* Belzona 1392 (Ceramic HT2) ,

Customer Location: Chemical Manufacturer, Warrington  
Application Date: August 2022

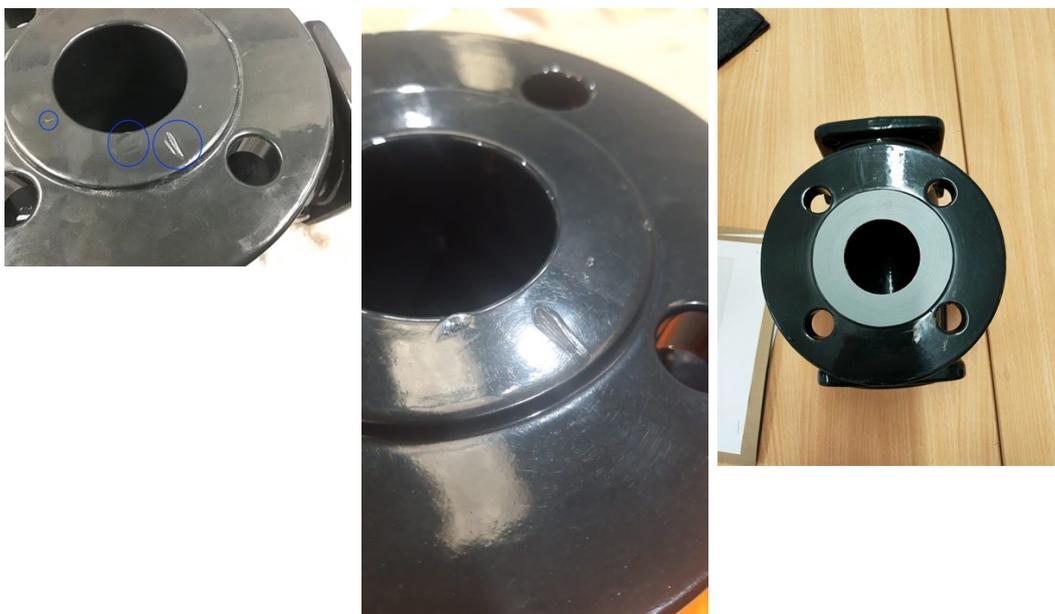
The client had an emergency shut down due to hot sulphuric acid leaking from a flange which had previously been coated with a fluoropolymer. The job was very small but was enough to shut the plant down as the existing coating had failed causing a serious and dangerous leak.

- \* 1. Areas of concern ,
- \* 2. Close-up of the fluoropolymer coating ,
- \* 3. Belzona 1392 repair ,

Damaged flange in a suction chamber.

The flange was taken out of service and taken to the Belzona workshop in Wrexham for repair. The applications team prepared the defective areas using mechanical tools to make the surface as rough as possible, angle out the grooves and get down to steel where possible. The surface was also cleaned and degreased prior to the application of a thick coat of Belzona 1392. The product was

applied level with the remainder of the flange face to ensure the gasket sat tightly on the surface. Once the product had cured, the component was transported back to the customer's facility.

The sites operating conditions were a maximum of 40% concentration of Sulfuric acid at 55°C making a high build coating of Belzona 1392 the ideal repair solution. Inspection reports from the site after a weekend in service deemed the repair to be very successful. The overall cost of the repair was less than £800 total.
