# Belzona Superwrap II Restores Strength to 26 Metre Sewage Pipeline

**Industry:** Water / Wastewater  
**Application:** VPF-Valves, Pipes and Fittings  
**Substrate:** Carbon Steel  
**Products:** \* Belzona SuperWrap II ,  
\* Belzona 1121 (Super XL-Metal) ,  
\* Belzona 4131 (Magma-Screed) ,

**Customer Location:** Water Authority, Scotland  
**Application Date:** August, 2021

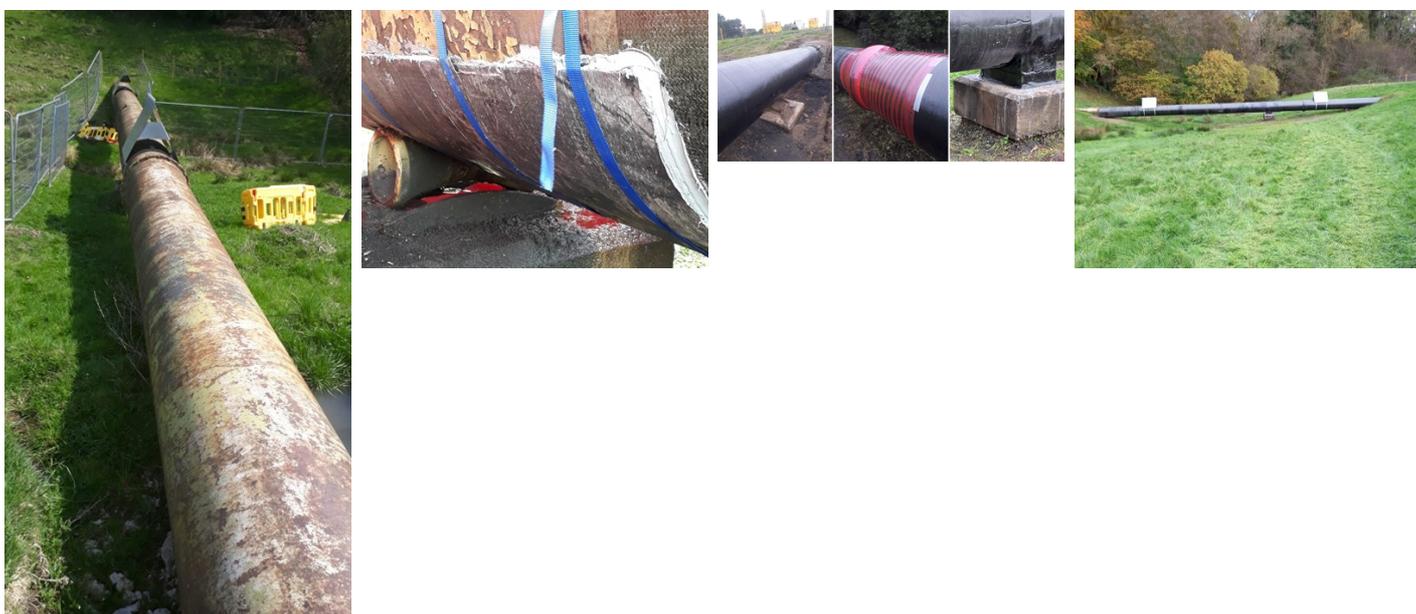
## Photograph Descriptions

The heavily corroded, 900mm diameter pipe is the main sewage line for a nearby town and if the issue was not rectified, there would be a huge cost for the asset owner. Pipe replacement was not an option due to complications in isolating this section. As this type of overland pipe is exposed to the elements, it often corrodes more than buried sections.

- \* 1. Corroded sewage pipe ,
- \* 2. Plate bonded in place ,
- \* 3. Completed wrap, Release film in place, Fabricated box ,
- \* 4. Pipe back in service with Belzona SuperWrap II completed ,

Firstly, the area was cleaned, and the pipe surface was grit blasted to the required standard. The live leaks were repaired by bonding prefabricated Belzona SuperWrap II plates over the leaking areas using Belzona 1121 (Super XL-Metal). Next, to provide complete protection, three layers of Belzona Superwrap II were mixed and applied to the external surface of the pipe. Once the pipe wraps had been applied, Belzona 9382 release film was applied around the wrap system and allowed to cure overnight.

An area of pipe around the support was very weak and required some reinstatement. The area had a very thin wall and grit blasting in this area was not possible, due to the inevitability of blasting through the pipe wall and causing catastrophic failure and a major environmental leak. Belzona UK was able to come up with an innovative solution to this unusual situation which involved the fabrication of a box using Belzona SuperWrap II to encapsulate the entire area including the support. This would then collect the leaking material from the pipe and when full, it would be strong enough to hold the material inside the box allowing the sewage to continue to run through the pipe with no further leakage into the environment.
