# Belzona seals bridge leaks

ID: 8863

Industry: General Industry  
 Application: TCC-Tanks and Chemical Containment Areas  
 Substrate: Carbon steel  
 Products: Belzona 1121 (XL Metal),

Customer Location: Scotland  
 Application Date: August 2022

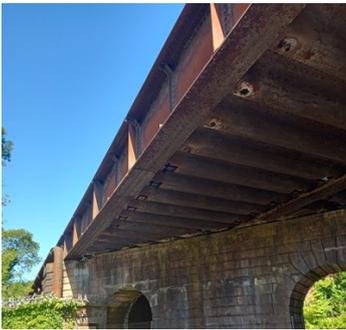
Bridge with leaking sections

A bridge had several gaps where water could penetrate & drip down onto a waterway below. A solution was required to seal these leak points.

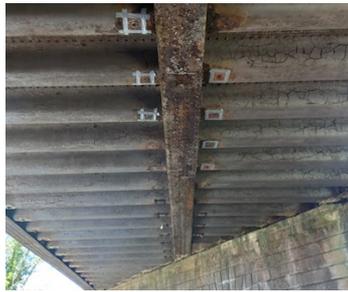
Areas marked out

The gaps were first marked out & prepared with an angle grinder. Suitably sized plates were sourced & prepared in the same way. The plates were then bonded to the surface. The slump resistance of the Belzona material was sufficient to hold the plates in place with no additional shuttering, saving time & cost.

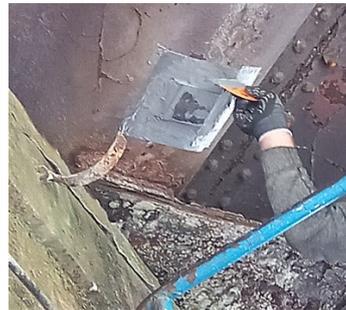
Belzona 1121 plate bonding

Belzona 1121 was used due to its extended working life, this feature was beneficial on this application as the works were carried out from a MEWP & time was needed to position in between the plate applications.

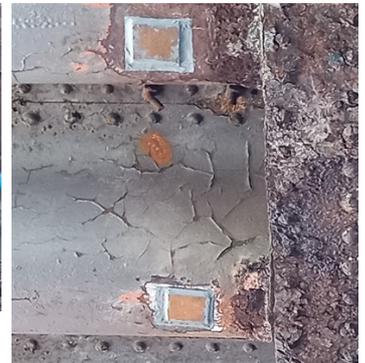
Application 18 months later

The application was reviewed 18 months later and is in perfect condition
