Belzona seals bridge leaks

ID: 8863

Customer Location: Scotland
Application Date: August 2022

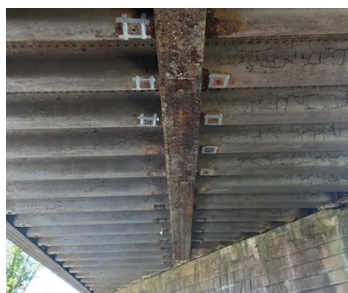
Areas marked out

The gaps were first marked out & prepared with an angle grinder. Suitably sized plates were sourced & prepared in the same way. The plates were then bonded to the surface. The slump resistance of the Belzona material was sufficient to hold the plates in place with no additional shuttering, saving time & cost.

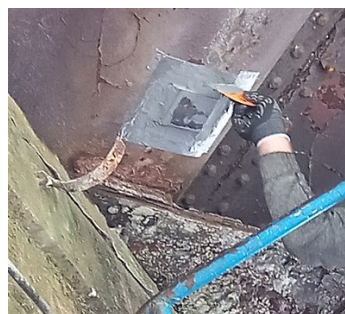
Belzona 1121 plate bonding

Belzona 1121 was used due to its extended working life, this feature was beneficial on this application as the works were carried out from a MEWP & time was needed to position in between the plate applications.

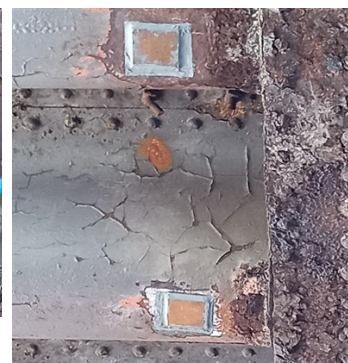
Completed application
