Belzona seals the base of storage tank

ID: 8865

Industry: Chemical & Petrochemical
Application: GSS-Gaskets, Seals and Shims
Substrate: Carbon steel
Products: Belzona 3921
Belzona 3131 WG Membrane
Belzona 9311

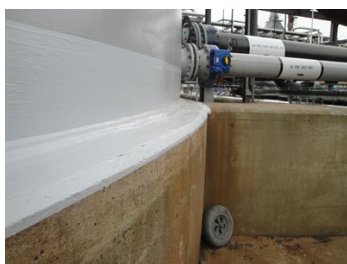
Original mastic failure

A large diameter storage tank had a mastic seal installed between its annular rim & concrete base. This mastic had become disbonded due to its lack of flexibility. A solution was required to seal this gap to prevent corrosion whilst maintaining flexibility.

The seal area on the newly painted tank was marked out & abraded to a 40 micron profile. Belzona 3921 was then applied followed by two coats of Belzona 3131 incorporating the 9311 reinforcing sheet.

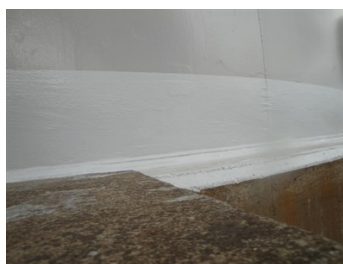
Close up of application

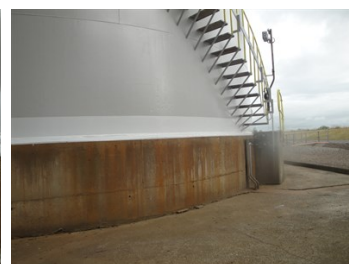
Completed application

The system has now been used on many tanks onsite & proved effective at preventing water ingress long term.
