BELZONA SEALS CONDENSER EXPANSION JOINT

Customer Location: Energy company, Kansas, USA

Application Date: March 2007

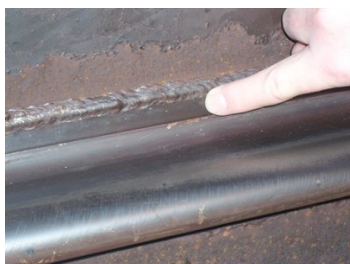
The efficiency of the unit was low because of the leaks in the expansion joint.

- * Leaking expansion joint ,
- * Mixing Elastomer ,
- * First coat ,
- * Second & Third coat ,

Application was carried out in accordance with Belzona Know-How System Leaflet HEX-5. The surface was prepared with a vacublast unit. After Conditioning, three coats of Elastomer were applied to the expansion joint and approximately one inch beyond the joint.
