Belzona Refurbishes a heat exchanger in the Sugar Industry

Industry: Sugar
 Application: HEX-Heat Exchangers
 Substrate: Steel
 Products: * Belzona 1511 (Super HT Metal) ,
 * Belzona 1391S ,

Customer Location: Austria
 Application Date: August 2022

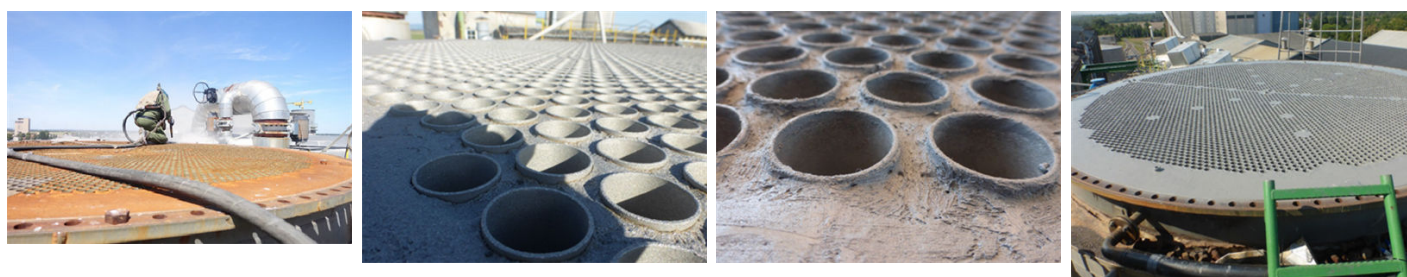
The head plate of the heat exchanger was very badly corroded and was already showing in part considerable loss of wall thickness.

- * 1: Blasting Surface ,
- * 2: Surface after Blasting ,
- * 3: Application of Belzona 1511 ,
- * 4: Completed application with Belzona 1391S ,

In July 2020 we applied test coatings in a number of areas. Inspection on March 15, 2022 confirmed Belzona test areas were error free. This gave the go ahead for Belzona to refurbish the heat exchanger.

The plate was blasted in accordance with the Belzona IFU. The plate was washed twice with Saltaway + deionized water + blown dry. The application was carried out in accordance with Belzona System Leaflet HEX-1 and HEX-3.
