Belzona Refurbishes a heat exchanger in the Sugar Industry

Application: HEX-Heat Exchangers

Application Date: August 2022

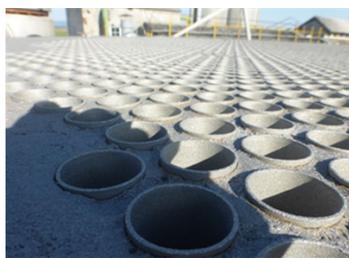
The head plate of the heat exchanger was very badly corroded and was already showing in part considerable loss of wall thickness.

- * 1: Blasting Surface ,
- * 2: Surface after Blasting ,
- * 3: Application of Belzona 1511 ,
- * 4: Completed application with Belzona 1391S ,

The plate was blasted in accordance with the Belzona IFU. The plate was washed twice with Saltaway + deionized water + blown dry. The application was carried out in accordance with Belzona System Leaflet HEX-1 and HEX-3.
