Belzona Restores a pump Impellor

ID: 8874

Industry: *Fluid Flow*
Application: *CEP-Centrifugal Pumps*
Substrate: *Carbon steel*
Products: *Belzona 1311 (Ceramic R Metal),
Belzona 1341 (SuperMetalGlide),*

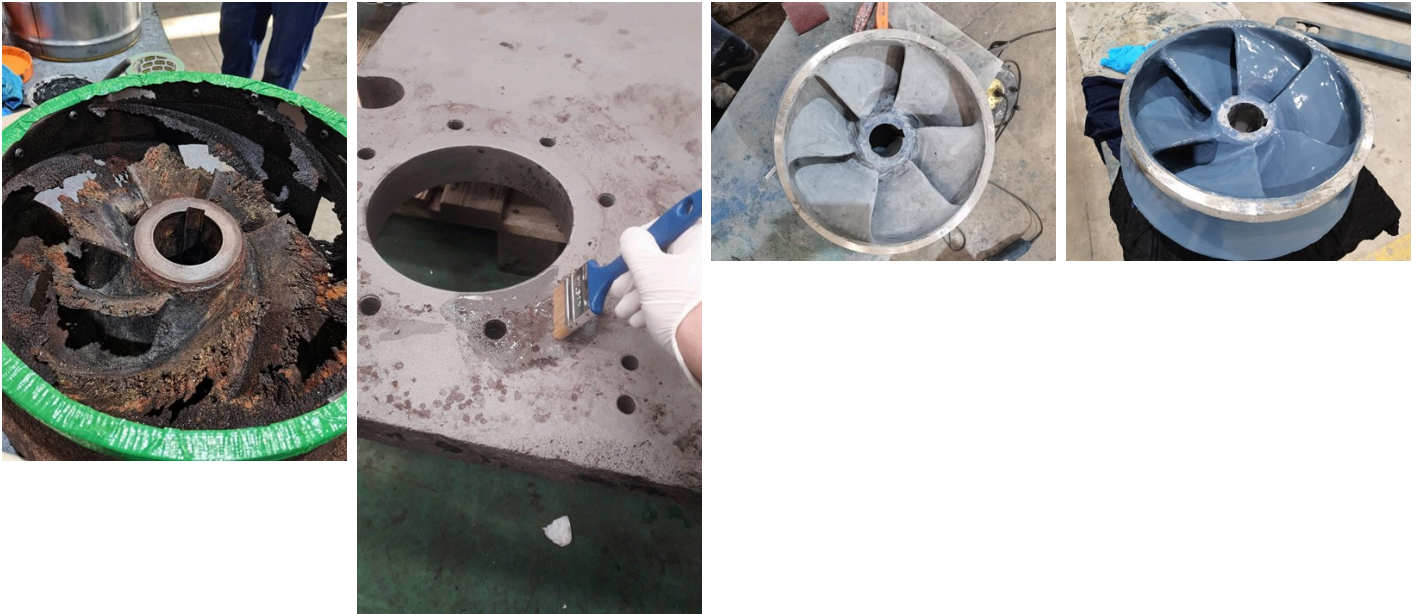
The impeller had suffered from significant erosion corrosion damage, leading to the need to replace.

Application was carried out in accordance to Belzona system leaflet CEP-01. The impeller was first blasted to achieve a min 75 micron profile and SA2.5 finish prior to the rebuilding. It was then balanced before being returned to service.

Belzona was able to renew this heavily worn and corroded pump impellor, extending its life span further - saving it from the scrap heap!
