# Belzona Restores a pump Impellor

ID: 8874

Industry: Fluid Flow  
Application: CEP-Centrifugal Pumps  
Substrate: Carbon steel  
Products: Belzona 1311 (Ceramic R Metal),  
Belzona 1341 (SuperMetalGlide),

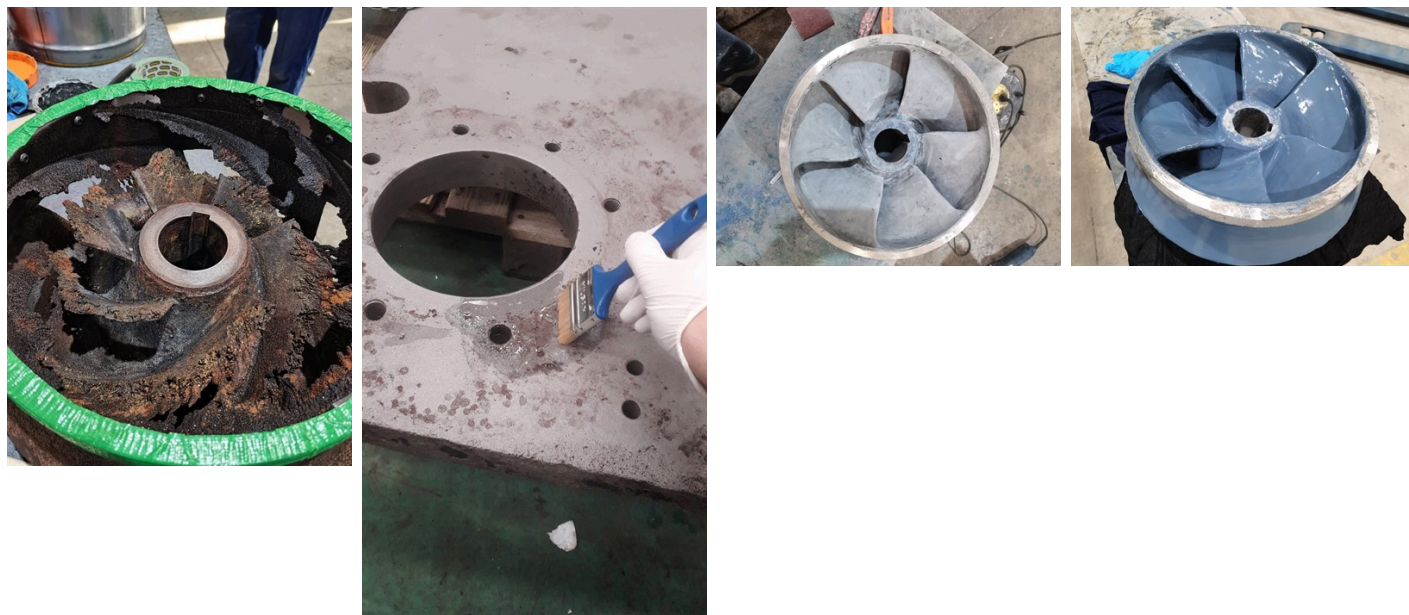
The impeller had suffered from significant erosion corrosion damage, leading to the need to replace.

Application was carried out in accordance to Belzona system leaflet CEP-01. The impeller was first blasted to achieve a min 75 micron profile and SA2.5 finish prior to the rebuilding. It was then balanced before being returned to service.

Belzona was able to renew this heavily worn and corroded pump impeller, extending its life span further - saving it from the scrap heap!
