# Protection of the discharge pipe area on ship

ID: 8880

Customer Location: *Port of Odense (Lindoe ship yard)*  
Application Date: *26-10-2022*

Substrate: *Carbon steel*  
Products: *Belzona 1391T*

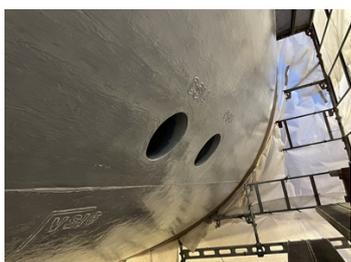
*The original glass flake coat had broken after a few years in service.  
This leaves the ship unprotected and vulnerable to corrosion.*

initial condition of ship

The area was grit blasted, roughness was measured and the salt contamination determined (result ok)  
Two coats of 1391T were applied

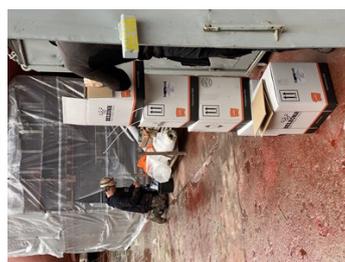
during application

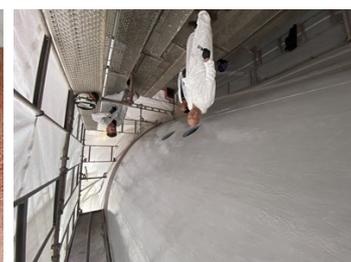
application complete
