Autoclave Repair using Belzona Superwrap II

ID: 8881

Problem

Leaks on the weld seam of the water-cooled jacket of this process vessel.

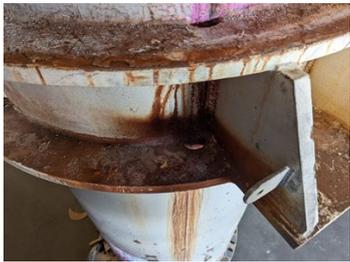
Initial condition

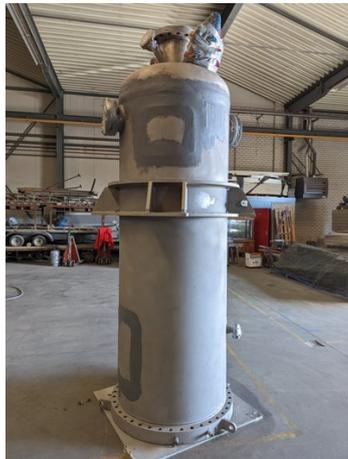
Plate bonding applied

Application carried out in accordance with a modified version of Belzona Know-How System Leaflet VPF-11. After blasting, the weak spots in the mantle are filled with the Belzona 1111 metal paste. Then the wrapping repair was carried out in at least 3 layers. The resin selected for this application is the Belzona 1983, because of the temperatures and the longer processing time. Belzona SuperWrap II is a composite repair that strengthens weaker metal structures on pipes and process vessels, mainly when applied on high-pressure systems.

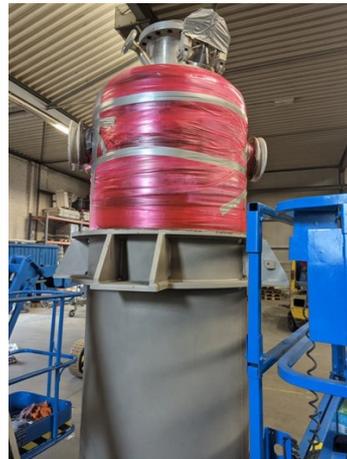
Application of Belzona
SuperWrap II

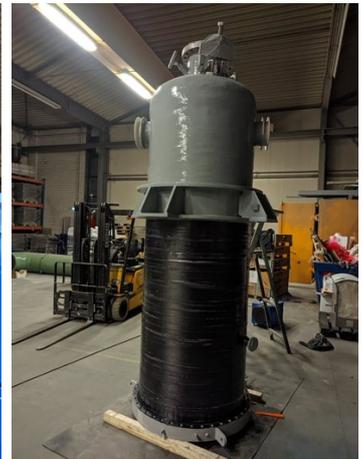
Complete application

A composite repair was carried out on a process vessel in the chemical industry using Belzona SuperWrap II. In order to prevent further leaks and to extend the life of the process vessel.
